TECHNICAL REPORT ARLCD-TR-81016

EVALUATION OF CONTINUOUS-CAST STEEL FOR PROJECTILE BODIES

US ARMY ARMAMENT RESEARCH AND DEVELOPMENT COMMAND
LARGE CALIBER
WEAPON SYSTEMS LABORATORY
DOVER, NEW JERSEY

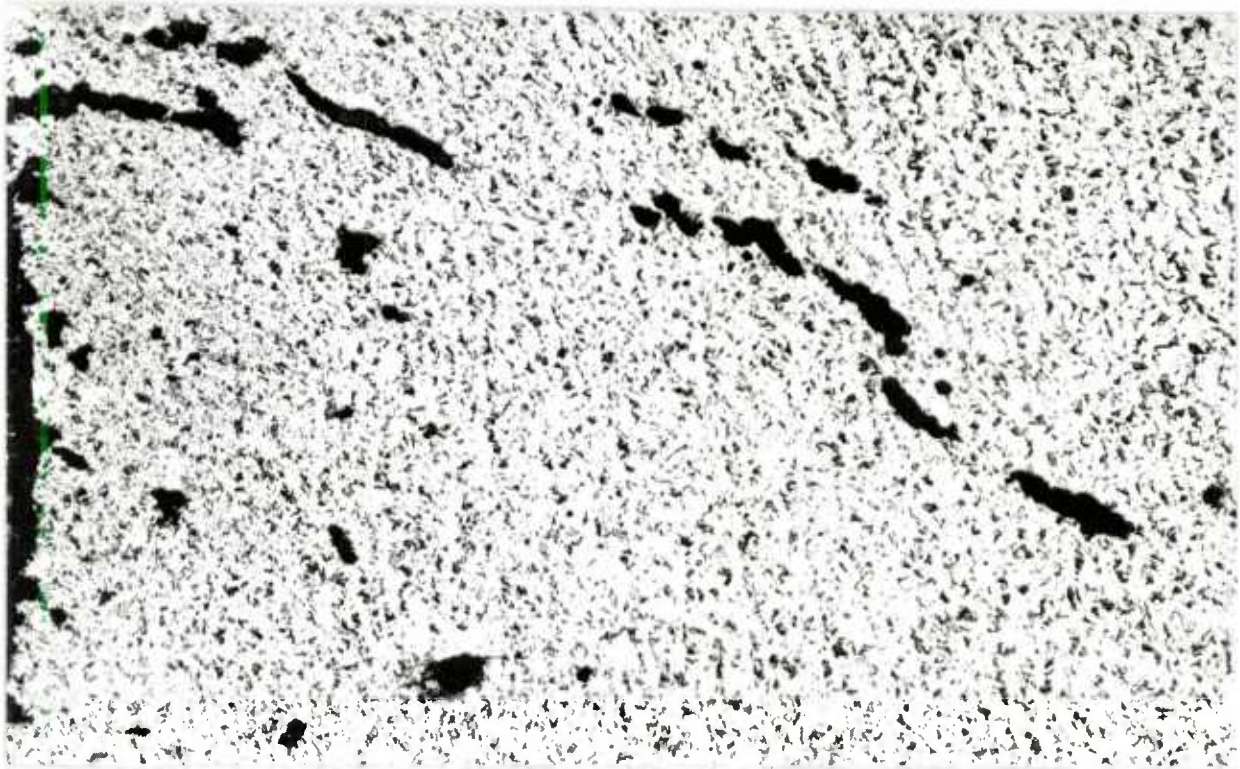
Figure 37. Dendritic porosity in base of projectile made from Roblin Steel product, picral etch (100X)

Some scattered porosity was also evident in the base of the projectile body, as indicated in figure 37. This defect appears to be dendritic porosity which did not close during forging since the base does not undergo as much deformation as the sidewalls. A comparison of the microstructure in figure 37 with the microstructure in figures 22, 23, 25 and 26 shows the degree of refinement obtained by reheating for forging.
